CONNECTICUT RIVER BASIN  
HOLYOKE, MASSACHUSETTS

WHITING STREET POND DAM  
MA 00070

PHASE 1 INSPECTION REPORT  
NATIONAL DAM INSPECTION PROGRAM

AUGUST 1978

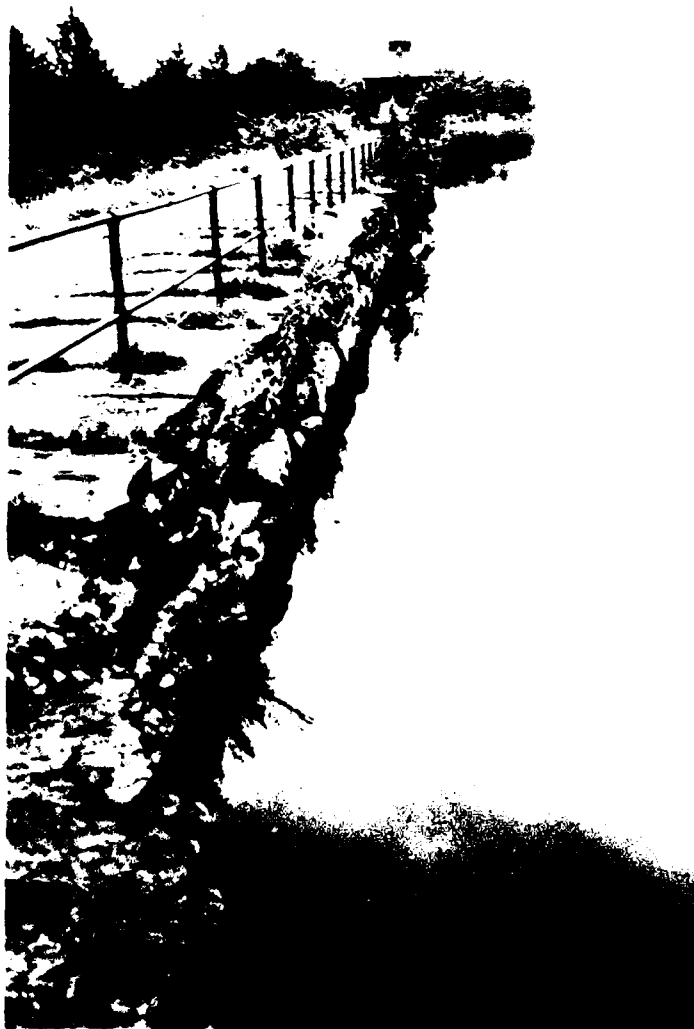
The upstream slope, which is stone masonry and almost vertical, appears above the water line to be in good condition, there are, however, a few missing stones at several locations and much of the mortar pointing is loose and/or missing (See Photograph No. 14). There is some vegetation growing through the open masonry joints.

The upstream slope appears above water line in good condition, however there are a few missing stones at several locations and much of the mortar pointing is loose and or missing. Also some vegetation growing through the open masonry joints.

14. CLOSE UP VIEW OF POINTING ON UPSTREAM STONE MASONRY FACE  
NOTE MISSING MORTAR AND VEGETATION IN JOINTS

4. The owner should develop a formal warning system with local officials for alerting downstream residents in case of emergency.
5. The missing stones in the masonry portion of the dam should be replaced and all joints repointed.
